Manhole Inspection Summary

Manhole # S15C__043MH

Location Address: **2546 WHITMORE**

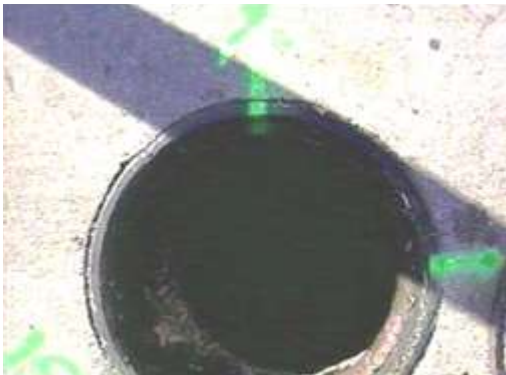
Defect 2

Offset: **4** (in.)

Condition: ☐ Sound ☐ Cracked ☐ Root Intrusion ☐ Loose Brick ☒ **Deteriorated**

offset frame and deteriorated frame adjustment

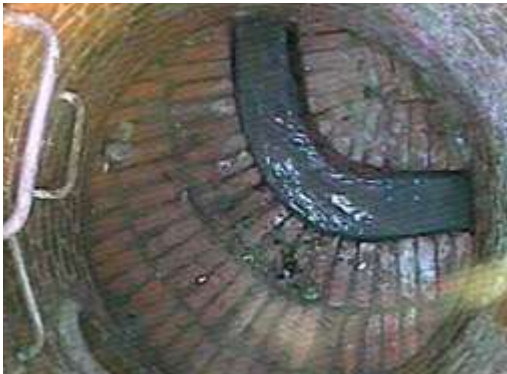
Defect 1

corroded step

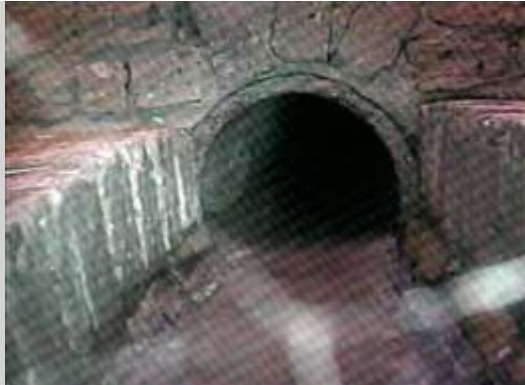
12 O'Clock Outflow

Pipe Height: (in.) Direct
Pipe Material: **Clay** ☐ Pipe Lined
Invert Depth: **6.73** (ft.) Flow Characteristics: **Slow**
Deposits: ☒ None ☐ Mud ☐ Sludge ☐ Debris ☐ Grease
Silt Depth: (in.) Deposits Extent:
Infiltration: **None** Pipe Seal Cond: **Sound**

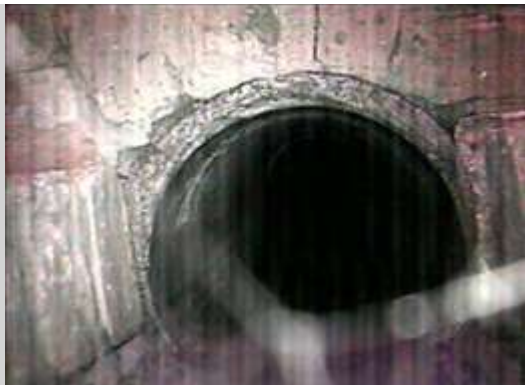
3 O'Clock Inflow

Pipe Height: (in.) Direct
Pipe Material: **Clay** ☐ Pipe Lined
Invert Depth: **6.71** (ft.) Flow Characteristics: **Slow**
Deposits: ☒ None ☐ Mud ☐ Sludge ☐ Debris ☐ Grease
Silt Depth: (in.) Deposits Extent:
Infiltration: **None** Pipe Seal Cond: **Sound**

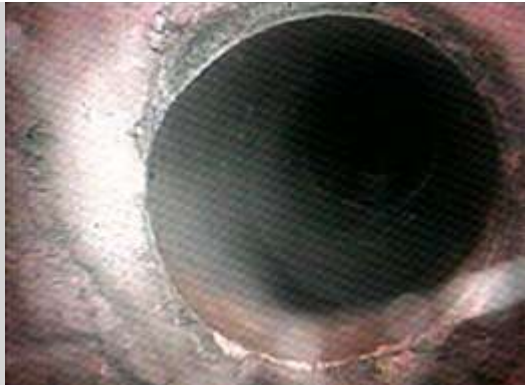
8 O'Clock Inflow

Invert Depth: **5.50** (ft.) Flow Characteristics: **None**

Infiltration: **None**

Pipe Seal Cond: **Sound**
